Manhole Inspection Summary

Manhole # S13MM_047MH

Insp Date: **3/24/08 2:07 PM**

Location Address: **2212 KOKO LN**

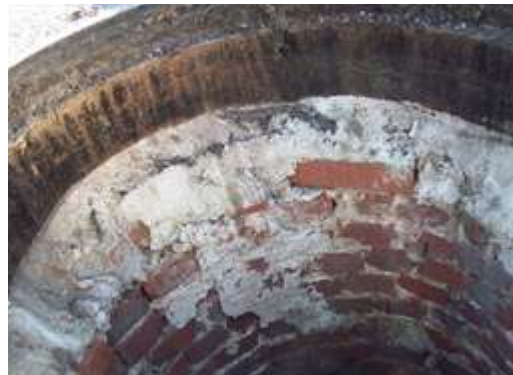
Defect 4

Condition: ☐ Sound ☒ **Cracked** ☐ Root Intrusion ☐ Loose Brick ☐ Deteriorated

CHIMNEY CRACKED

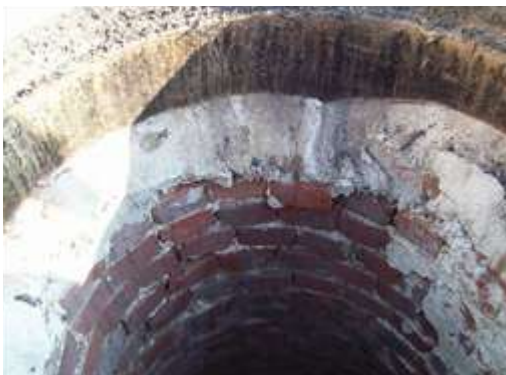
Defect 3

Condition: ☐ Sound ☒ **Cracked** ☐ Root Intrusion ☒ **Loose Brick** ☒ **Deteriorated**

Infiltration: ☐ None ☐ Joint ☒ **Cracks** ☒ **Mortar** ☐ Roots ☒ **Wall**

BARREL CRACKED, LOOSE BRICKS AND DETERIORATED.

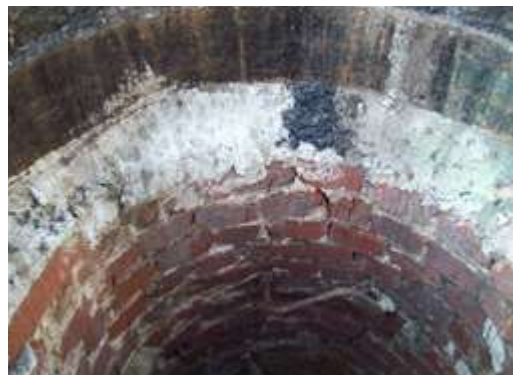
Defect 1

Count: **19** Missing: **0** ☒ **Corroded**

BARREL AND CORBEL INFILTRATION, CORRODED STEPS

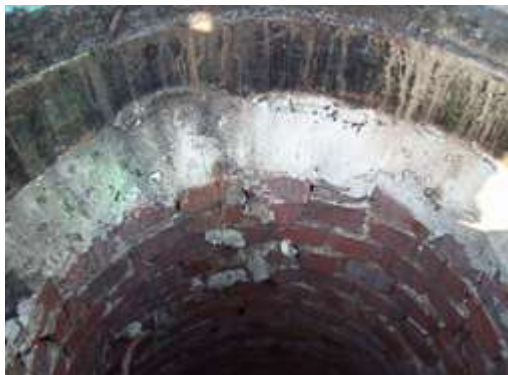
Defect 2

Condition: ☐ Sound ☒ **Cracked** ☐ Root Intrusion ☒ **Loose Brick** ☒ **Deteriorated**

Infiltration: ☐ None ☐ Joint ☒ **Cracks** ☒ **Mortar** ☐ Roots ☒ **Wall**

CORBEL CRACKED, LOOSE BRICKS
AND DETERIORATED.

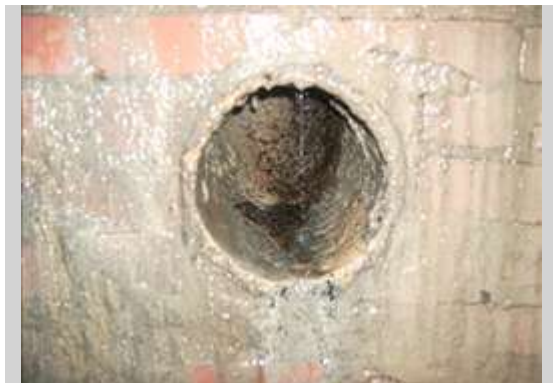
12 O'Clock Inflow

8 in. Circular Gravity Sewer
Pipe In @ 12 O'Clock

Deposits: ☐ None ☐ Mud ☐ Sludge ☐ Debris ☒ Grease

Silt Depth: **0** (in.) Deposits Extent: **Light**

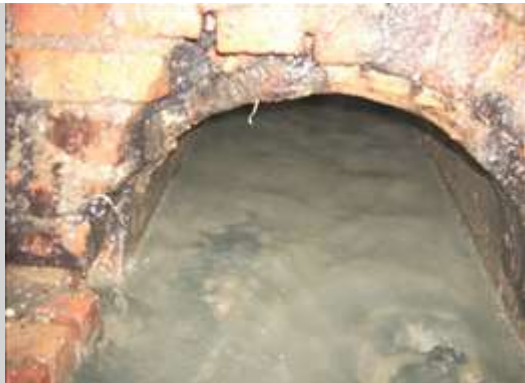
6 O'Clock Inflow

24 in. Circular Gravity Sewer

Deposits: ☐ None ☐ Mud ☒ Sludge ☒ Debris ☐ Grease

Silt Depth: **10** (in.) Deposits Extent: **Light**
